# TRD Meeting

## Statusreport

## TRD Straw-Modules

CERN, 16th July 2002

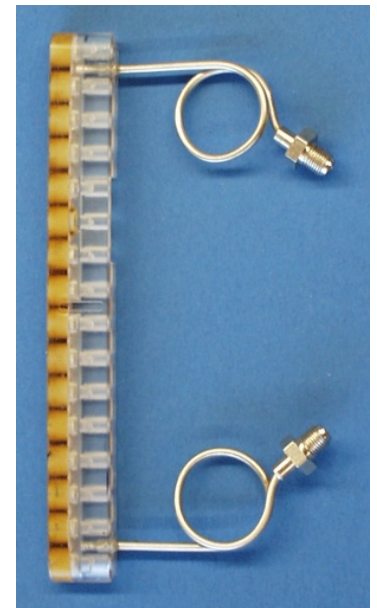
- **Module 448mm:**  
sealing with EPO-TEK 353ND broken  
⇒ EPO-TEK 353ND not useful for straw modules!
- **Module 376mm:**  
(repaired straws) sealing with EPO-TEK 353ND broken  
sealing PEEK-Polycarbonate leaky  
⇒ PEEK-tube replaced by stainless steel-tubes  
+ PC-adapter ⇒

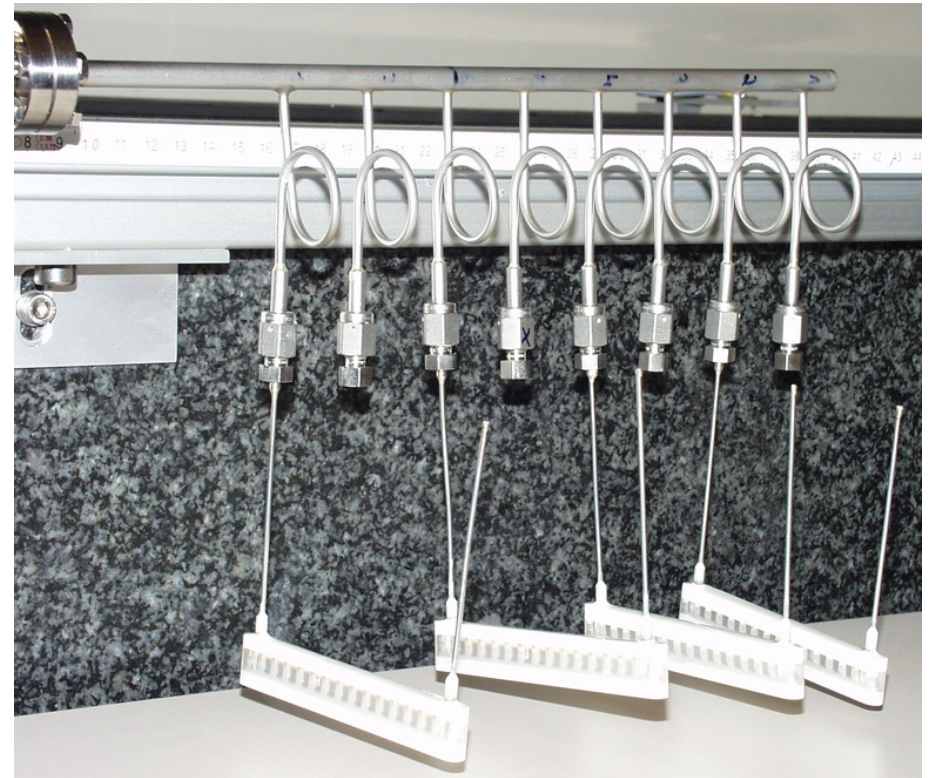
New Design:

Leak rate:  $q = 3 \cdot 10^{-5} \frac{l \cdot mbar}{s}$  (He)  
Space qualified?  $\Rightarrow$  Thermo Vacuum Test
